NOVEMBER 1, 2017

GALENA RIVER WATERSHED
HYDROLOGIC UNIT CODE 070600050307

GALENA RIVER WATERSHED RESOURCE INVENTORY

MIKE MALON
C.P.E.S.C., C.L.M.
GALENA, IL

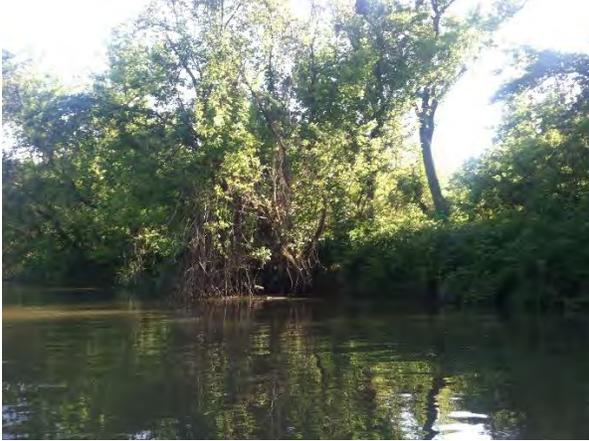
Figure 19-44. Elevated floodplain and eroded banks, observed even when visited during flood conditions.

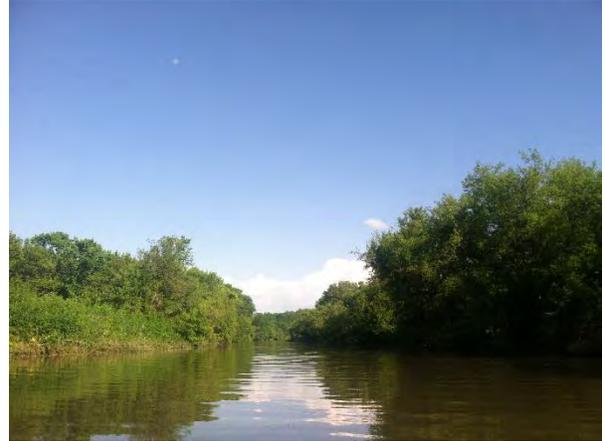
Figure 19-45. Conditions at LR2 closely resemble LR1.

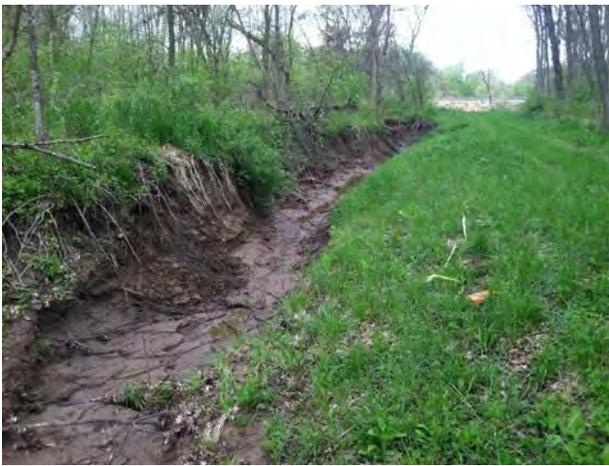
Figure 19-46. Channelization and erosion.

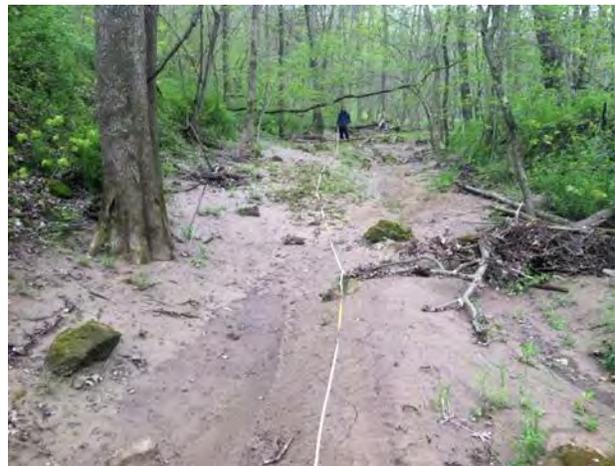
Figure 19-47. Sediment deposition.

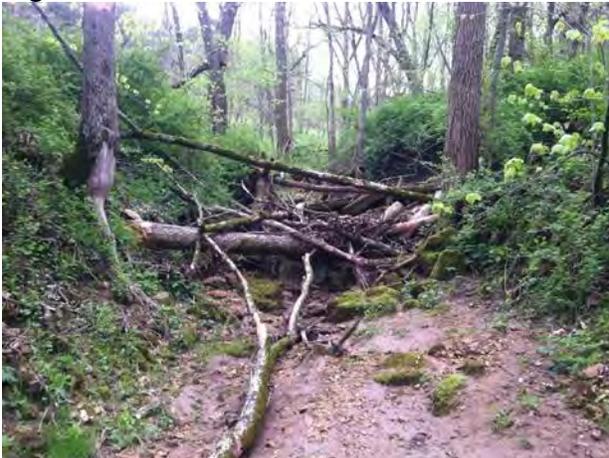
Figure 19-48. Debris jam.

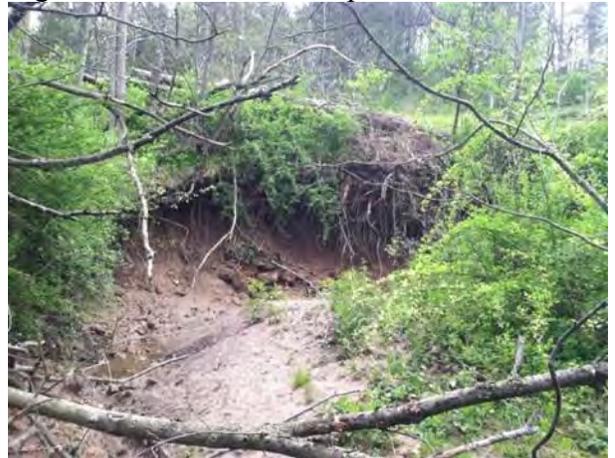
Figure 19-49. Bank erosion.

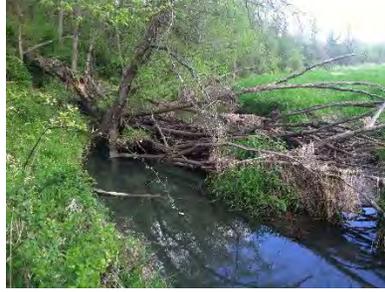
Figure 19-54. Beaver dam observed near sewage treatment plant.

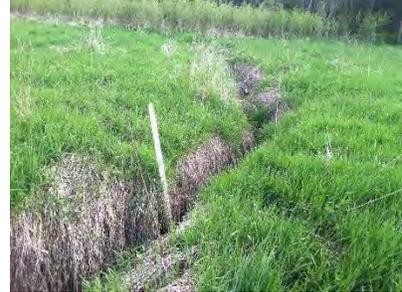
Figure 19-55. Extensive braided erosion observed in wetland floodplain.

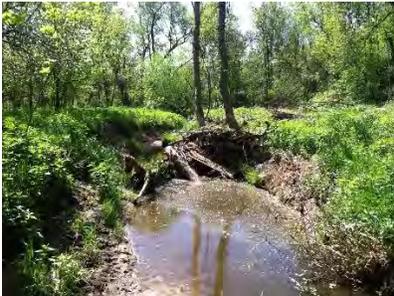
Figure 19-56. Extensive erosion throughout corridor.

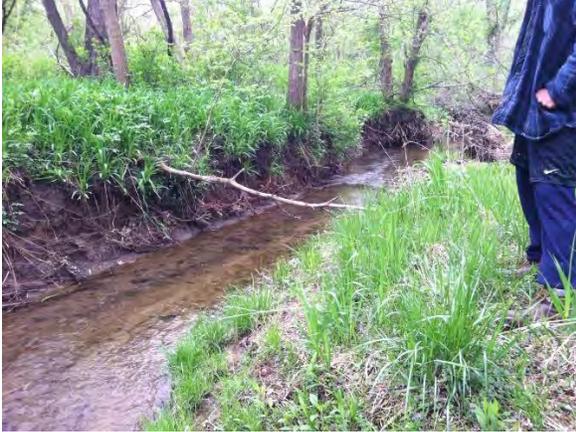
Figure 19-66. Erosion and channelization as observed in lower reaches of the BJ1 corridor.

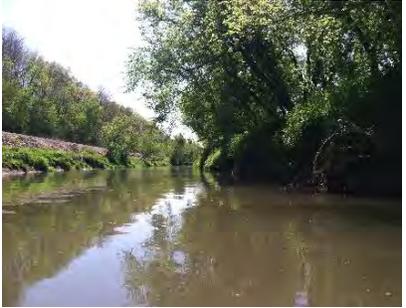
Figure 19-70. Railroad grade on left bank constricting channel.

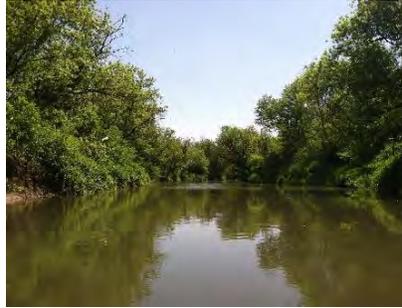
Figure 19-71. Some bank erosion can be observed on the left of this photo, but most erosion is hidden below the high water.

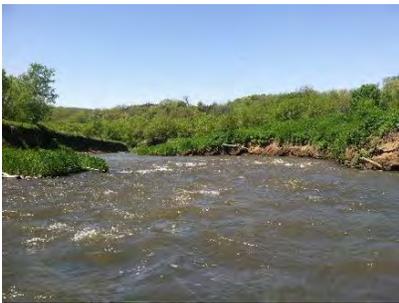
Figure 19-73. Eroded banks on both sides of river.

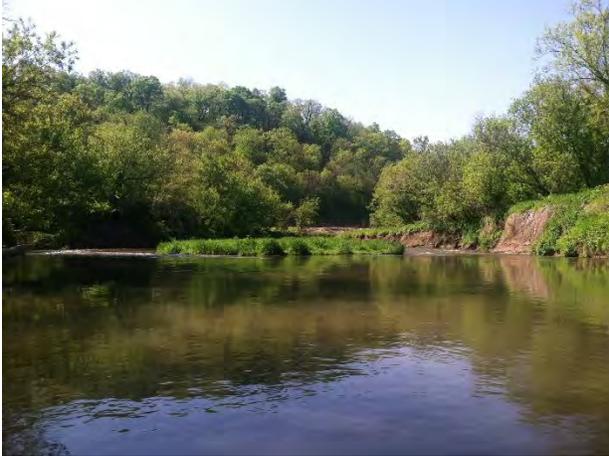
Figure 19-76. Top of MS 4. Note vegetated sediment slug in center of riffle and highly eroded banks.

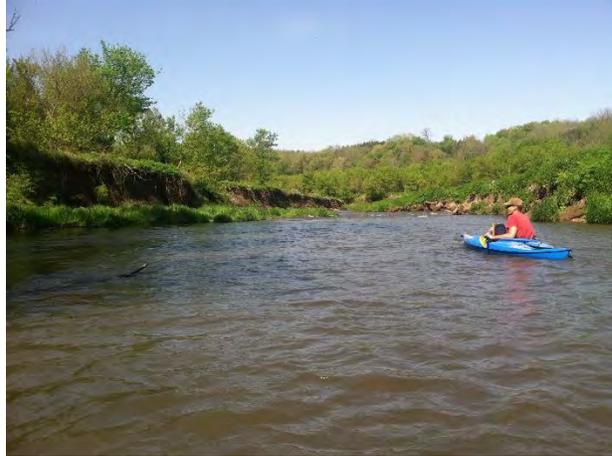
Figure 19-77. Highly eroded banks on both sides of channel.

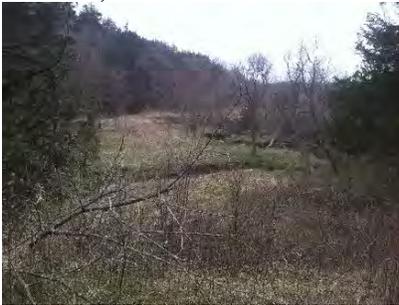
Figure 19-78. Eroded banks in MS Trib 1. Some natural stream sinuosity can be observed.

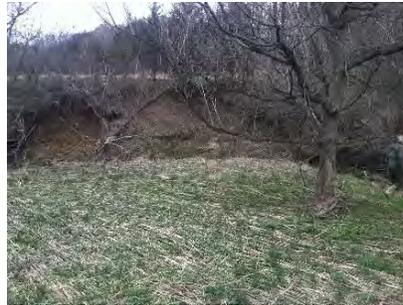
Figure 19-79. Eroded bank where flow is diverted by remains of mill dam. Adjacent vegetation indicates that recent out of bank flow occurred.

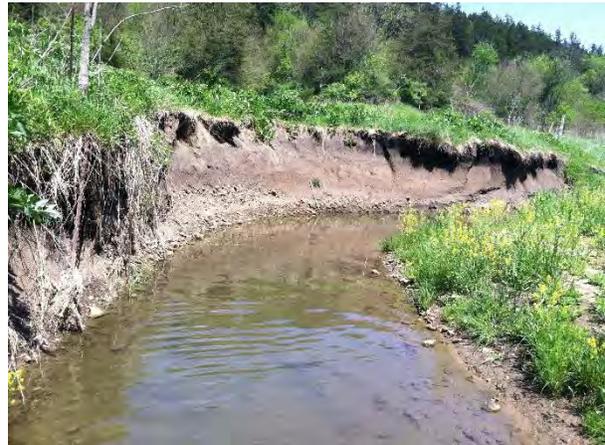
Figure 19-82. Eroded banks showing soil stratifications.

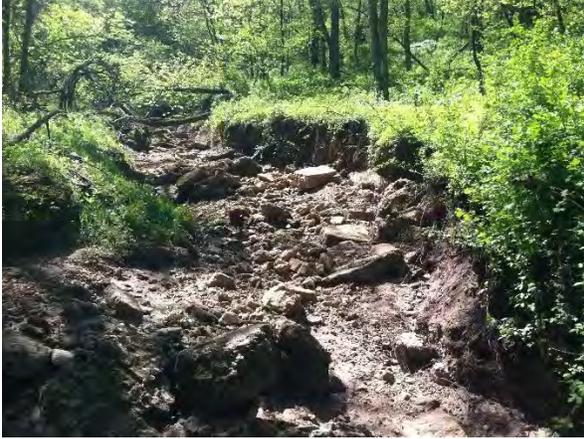
Figure 19-85. Representative channel with eroded banks.

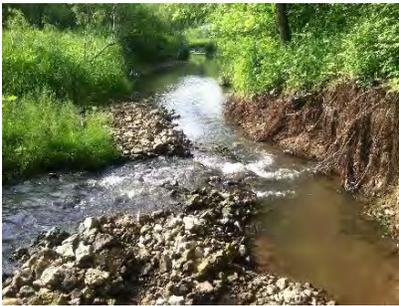
Figure 19-92. Eroded banks and large cobble substrate.
