NOVEMBER 1, 2017

GALENA RIVER WATERSHED
HYDROLOGIC UNIT CODE 070600050307

GALENA RIVER WATERSHED RESOURCE INVENTORY

MIKE MALON
C.P.E.S.C., C.L.M.
GALENA, IL

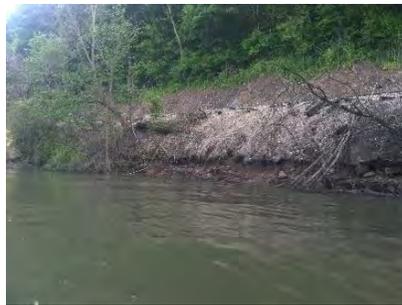
Figure 19-42. Eroded bank below adjacent railroad bed.

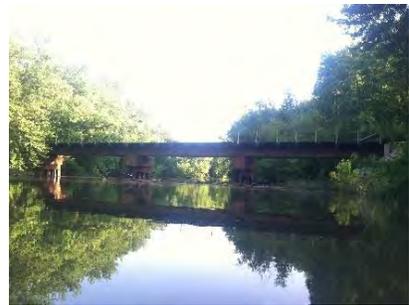
Figure 19-43. Railroad bridge at the mouth of the river and debris jam below.

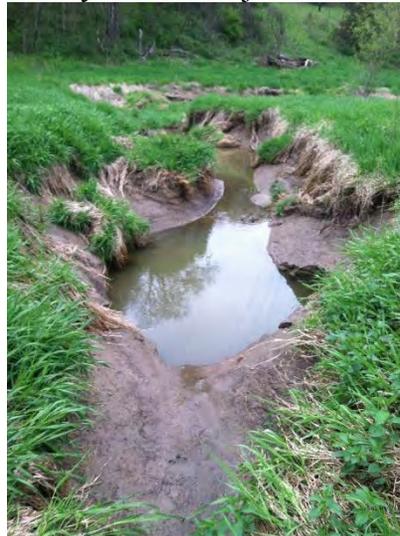
The LR TRIB 2 contains a sand bottom from its confluence with the Galena River to the culvert passing under the bike trail (approximately 640ft.). The extent of water in the tributary exists from the Galena River to this culvert, and approximately 105 ft. above the culvert. A head cut has formed from the improper inlet elevation of the culvert forming an eroded channel approximately 75 ft. long and four ft. deep. Above this scar no discernible channel is found for another 1000 ft., which appears to be a wetland field filled with vegetation rooted in sediment which has been deposited from upstream. Above this area, a small ephemeral channel can be found, which only flows during heavy rain. Evidence of stream features (riffle crests, eroded sediment slugs, and debris) can be found, but is not transporting material or contributing sediments on any consistent basis. Only one debris jam was observed in this corridor.

Figure 19-51. Headcut from low culvert elevation.

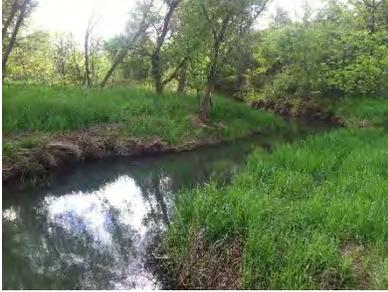
The West Galena corridor is extremely degraded, with channelization and erosion lining almost the entire corridor. From its confluence with the Galena River, this corridor travels past the sewage treatment plant, where the stream is narrow and deep, and the water level relatively consistent with the elevation of the pool of the Galena River. The banks are eroded and five debris jams were observed. A sixth jam was observed in this area created by beaver. Multiple trees lay fallen on the banks and could be added to the existing jams as weather events or deterioration exists. This area encompasses approximately 1000 ft., where a grassy wetland area emerges. In some places, the channel is braided into multiple channels coming from different directions. This area exists today largely as a sediment slug created by the extensive erosion upstream; likely close to 30,000 yd.³ of material. The channel bottom is primarily mud through this reach.

Figure 19-53. Deep narrow stream in lower reach of corridor.

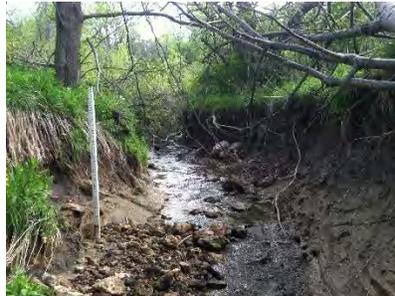
Figure 19-57. Extensive erosion. Note grade rod for scale.

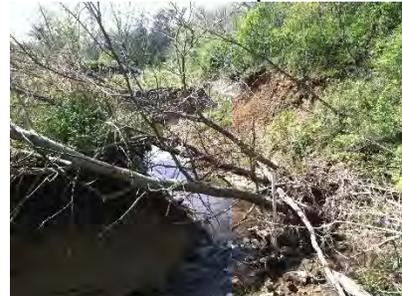
Figure 19-58. Extensive erosion. Note grade rod for scale.

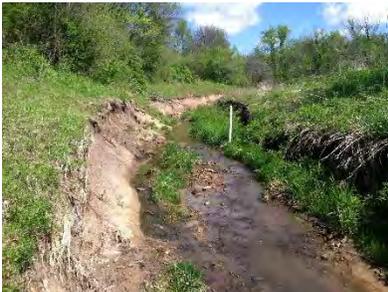
Moving upstream north of Ferry Landing road, the channel remains highly eroded and channelized, with 23 debris jams observed. An approximately 400 ft. length of stream was straightened in this area which is causing extensive downcutting and erosion which is affecting the upstream reaches of stream behind Greenwood Cemetery, as well as forming large gullies into the back yards along Red Gates Road. The straightening shows up on aerial imagery approximately 2012. Although this straightening is causing extensive damage, the erosion was likely existent long before the stream was straightened. There is a low degree of downward cutting of the stream through the floodplain, and what is more likely is that an extensive amount of sediment has been deposited into the floodplain from upslope over the more than 100 years of development and farming in this subwatershed. In this area, there is a high sand content in the soils and present in the streambed. Below Casey's gas station, the stream bed runs directly on bedrock for more than 800 feet, indicating that no further downcutting can occur in this reach.

Figure 19-59. Section of straightened stream; not grade rod for scale.

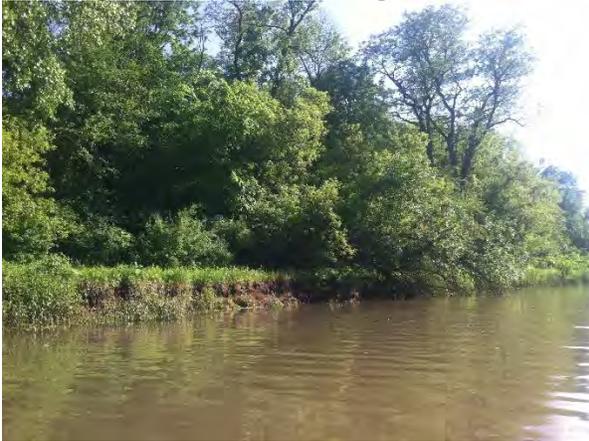
Figure 19-62. Eroded bank visible above flood waters.

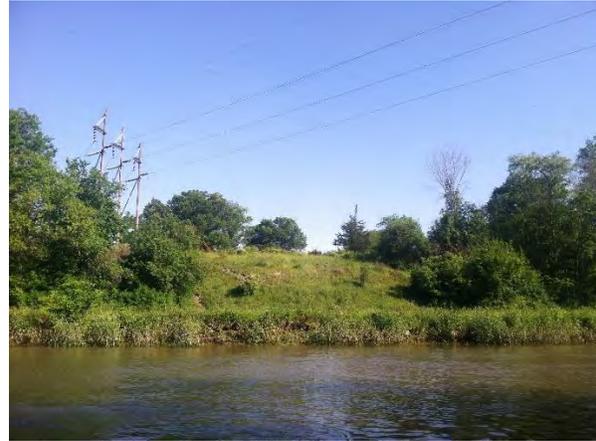
Figure 19-63. One of two areas in this reach cleared up to the river's edge.

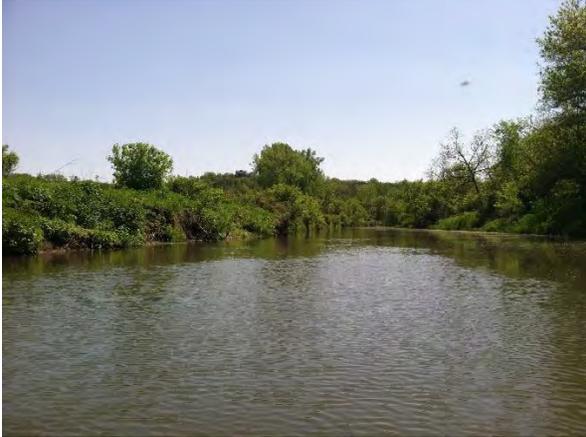
Figure 19-68. Shorter eroded banks in MS 1.

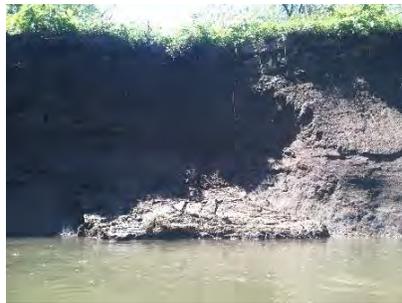
Figure 19-74. Active slumping on eroded bank. Note adjacent hole in bank with swallow nest.

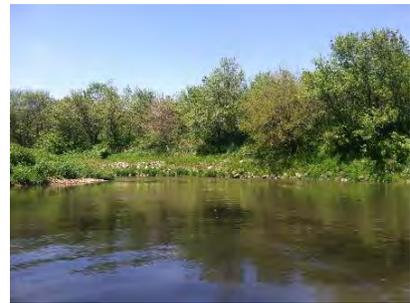
Figure 19-75. Riprap protection on stream bend.

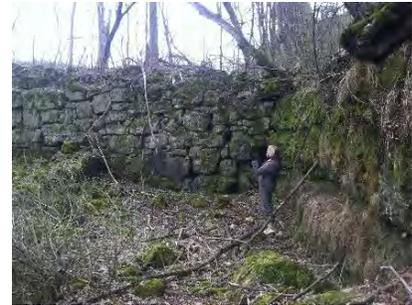
Figure 19-80. Remains of rock dam from former mill.

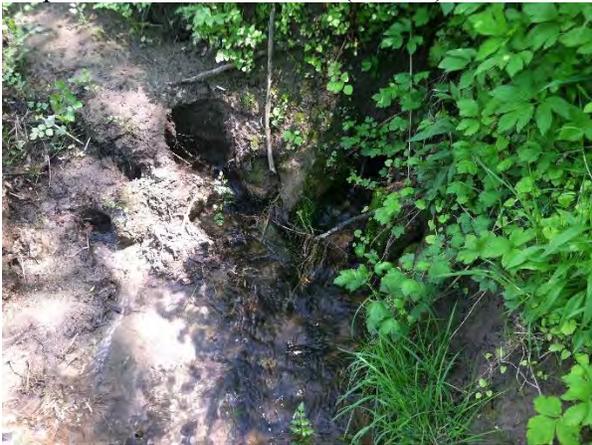
Figure 19-81. Springs contributing to stream reach.

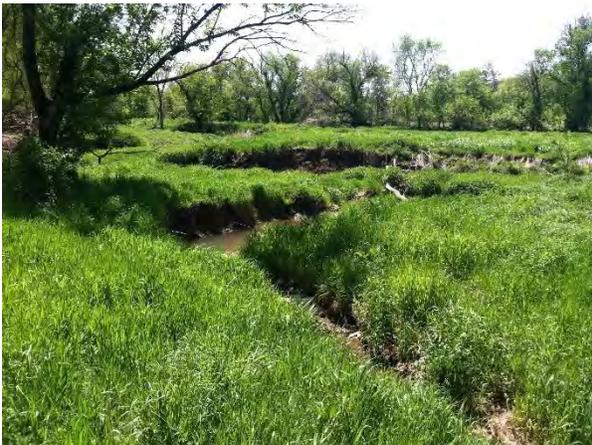
Figure 19-83. Natural sinuosity of the stream relieves erosive energy.

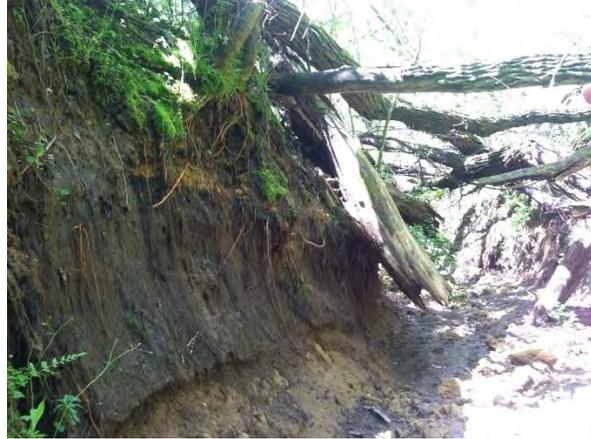
Figure 19-86. Eroded bank with debris.

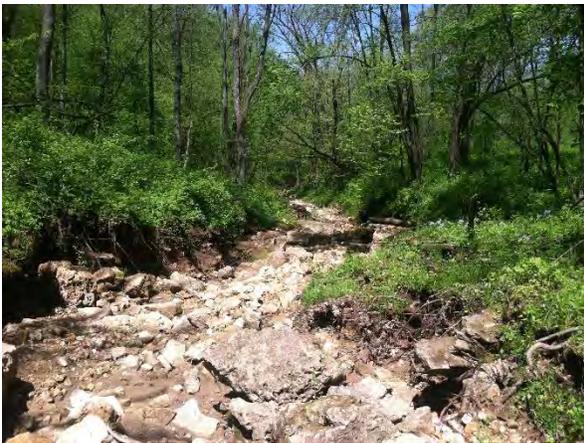
Figure 19-87. Dry channel with eroded banks.

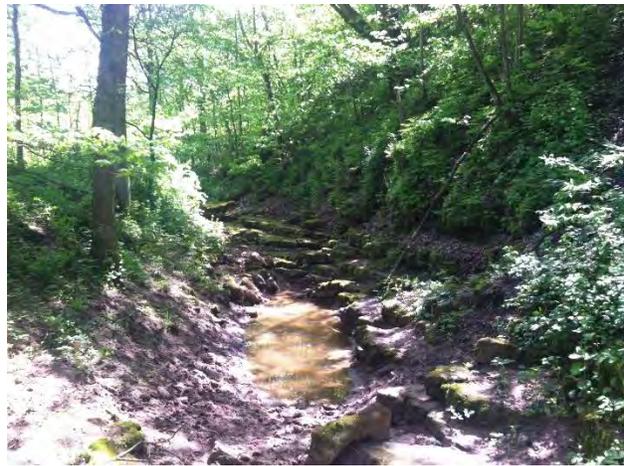
Figure 19-88. Small pool from previous flow below a bedrock channel bottom.

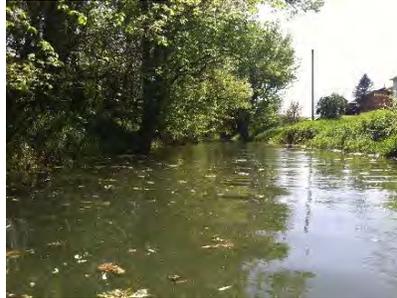
Figure 19-90. HB1 near the Meeker Street Bridge; its eroded banks are submerged under high water.

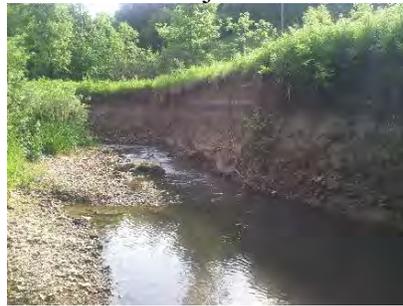
Figure 19-93. Eroded bank adjacent to Council Hill Rd. measures more than 12 ft. high.

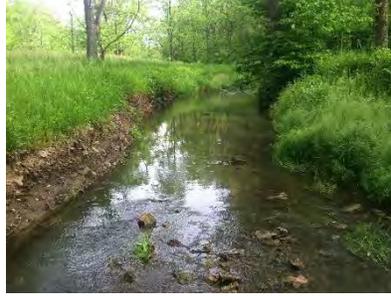
Figure 19-96. Five-foot-high eroded bank in planted riparian forest.

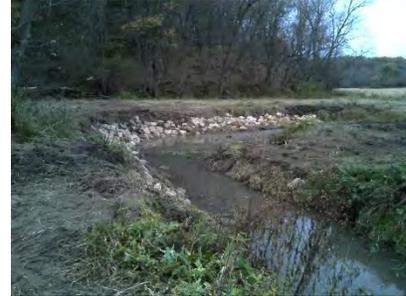
Figure 19-97. Stone toe bank protection installed in 2016.

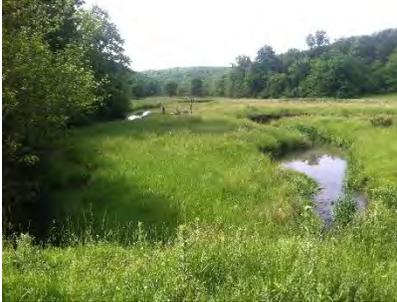
Figure 19-98. This highly sinuous reach meanders back and forth across the valley floor.

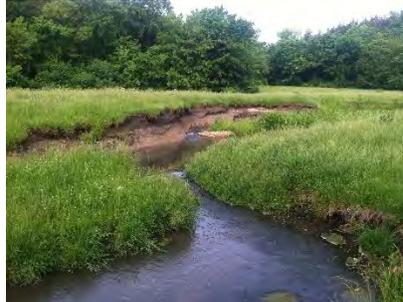
Figure 19-99. Eroded banks with actively slumping material. The soil layers visible in the bank indicate less legacy sediment than seen in other reaches of the watershed.

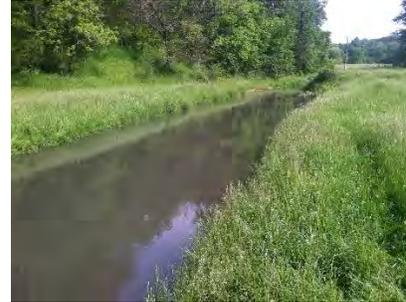
One small pool, three-quarters of a mile up the valley may hold the answer. While surveying this corridor, the typical riffle-pool-riffle-pool sequence followed with five to eight-foot eroded bends and cobbly riffles breaking up elevation changes from pool to pool. One pool is different. It holds noticeably more water than any of the others. The banks are neatly grassed over, and no more than one and a half feet high. The pool is 20 feet across and filled with fish, who likely overwinter and spawn here. This pool, in its wide valley and highly sinuous stream, looked like it would be just as easily found in the remote backcountry of Wyoming or Montana, and could very well be what much of Jo Daviess County looked like prior to European settlement. What makes this one lonely pool different? This is the question the surveyors asked. Analyzing the pool for more than an hour, every facet of hydrology came into question. Finally, the answer appeared: a beaver swam across the pool, from one side to the other. The depletion of the beaver

population falls right in line with history in the watershed; with settlement, mining, and logging the forests for timber. We are making tremendous strides towards many best management practices, such as bank stabilization, grassed waterways, and riparian buffers, but perhaps restoring nature's engineer has been dramatically overlooked- and perhaps the BMP needed most.

Figure 19-100. This one beaver pond may hold the answer to restoration in the watershed.

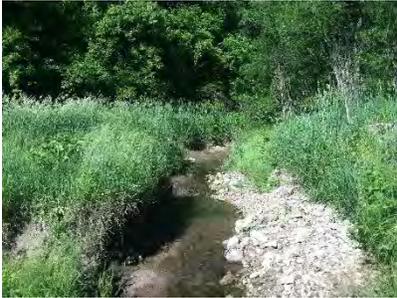
Figure 19-101. Eroded channel of HB Trib 1.

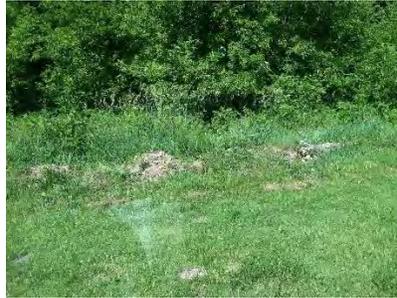
Figure 19-102. HB Trib 1 lies in the back of this photo below the overstory vegetation; in the foreground, the material dug from the channel can be seen piled adjacent to the stream.

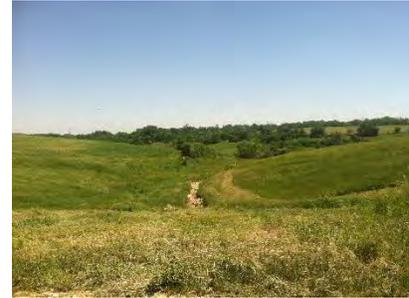
Figure 19-103. The headlands of HB Trib 1, with a scoured channel in the center of the photo.

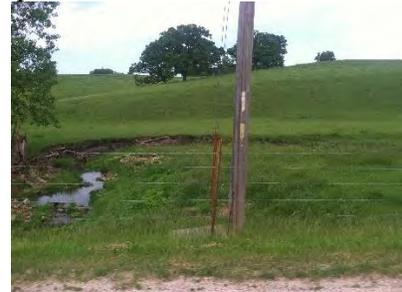
Figure 19-106. Eroded banks in pasture.

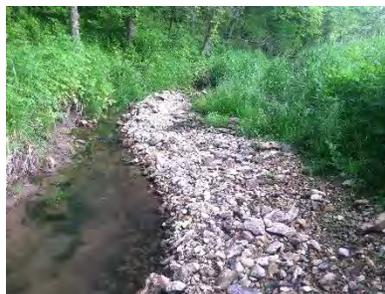
Figure 19-108. Cobble outwash forming permeable riffle.

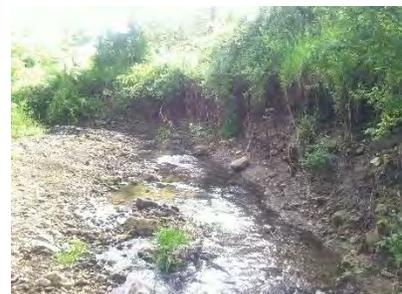
Figure 19-109. All bends in this reach are eroded. This bank measures five feet high.
